**UNITED STATES ENVIRONMENTAL PROTECTION AGENCY**

**Re: Request for Information  
Docket No. CWA-IR-15-010  
EPA Reconnaissance Inspection September 18, 2014  
U.T.A Mesivta of Kiryas Joel, Berdicheve Road, Kiryas Joel NY  
SPDES Permit Identification Number: NYR10X832**

United States Environmental Protection Agency  
Washington, D.C. 20460  
**Water Compliance Inspection Report**

**Attachment 1- Photographs taken at the UTA of Mesivta Upper (North) and Lower (South) Sites on September 18th, 2014. Taken by Murray Lantner, P.E., Environmental Engineer, Nikon Coolpix P510, EPA Region 2, DECA-WCB**

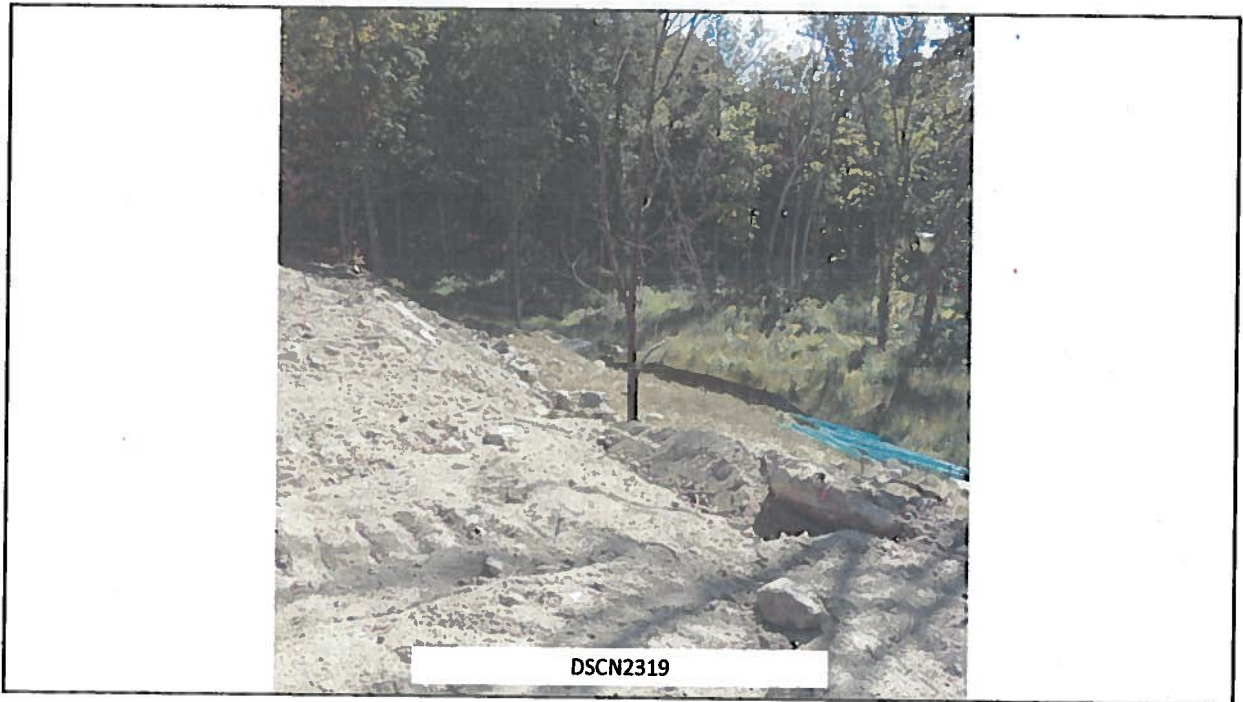
Photo ID No.	UTA Mesivta Site	Photo Description
DSCN2321	Lower	Unstabilized slopes at the southern portion of the lower site. Leading down to Forest Brook, which is shown in the photo. Silt fencing is shown in part of the photo. But in other parts of the photo silt fence missing or not maintained.
DSCN2322	Lower	Rock lined diversion swale along eastern boundary of the site.
DSCN2323	Lower	Rock lined diversion swale along eastern boundary of the site.
DSCN2324	Lower	Water flowing in Forest Brook at the upstream (northern) end of the Lower site. This is the location where the northern portion of the diversion swale enters the stream.
DSCN2325	Lower	Rock lined diversion swale along eastern boundary of the site.
DSCN2326	Lower	Gap in headwall at the northern end of the site that flows into Forest Brook. Rocks were placed in the eroded flow path here, but there were flow paths around the rocks that should be stabilized/additional BMPs used.

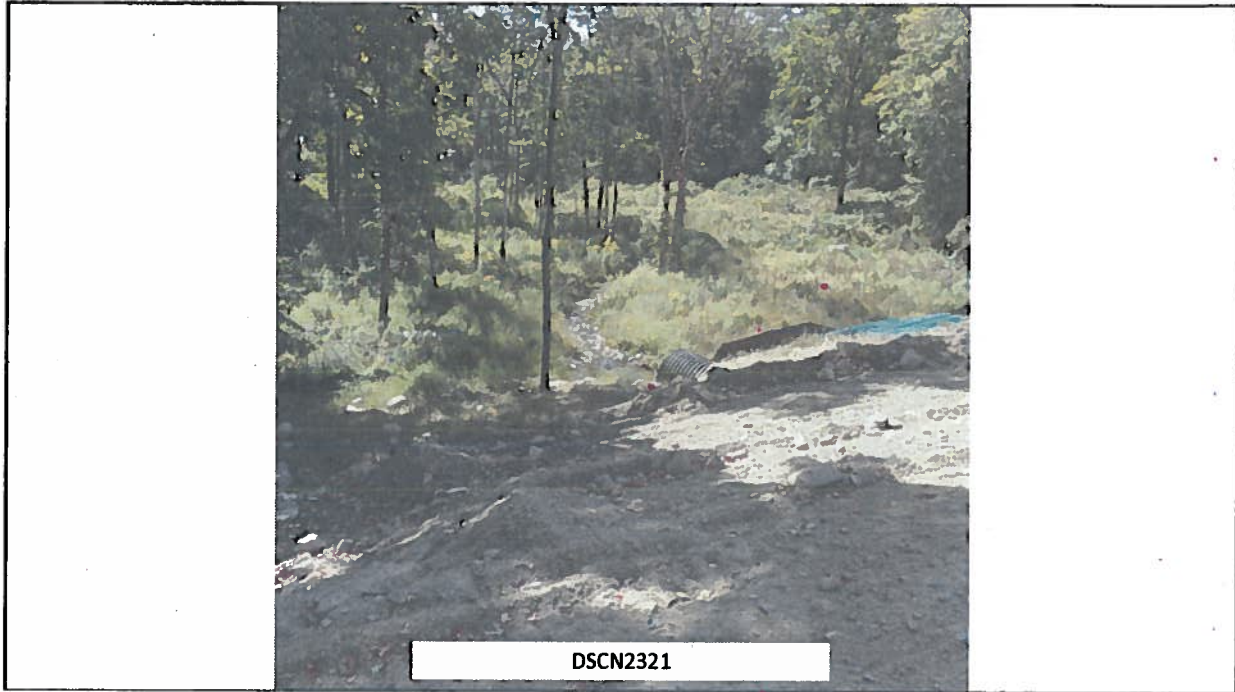
- a. As shown in photos 320 and 321 the slopes at the lower site were not stabilized and there were not stormwater Best Management Practices ("BMPs") in place at portions of the site near the stream. The Erosion Control Plan for the Lower site specifies that there will be silt fencing along the southwestern boundary of the site (See Erosion Control Plan Attachment 2)

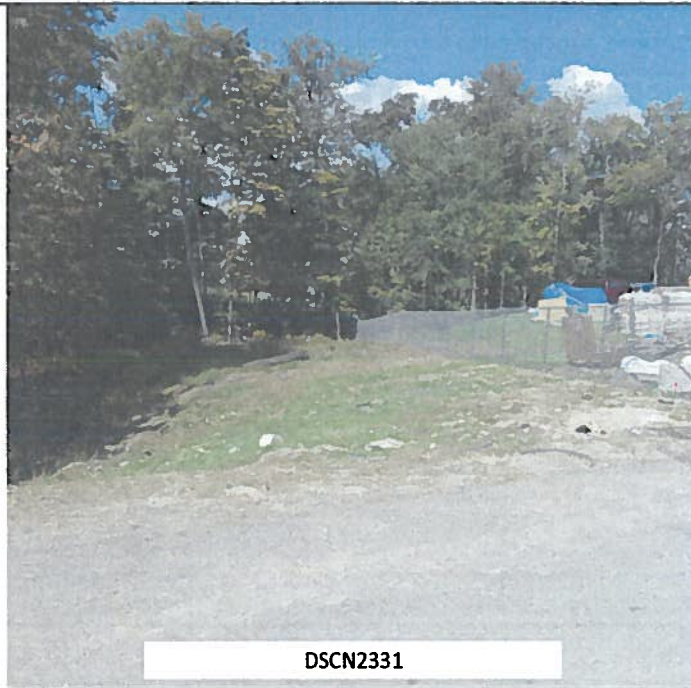
DSCN2331

- a. As shown in photos 330 and 331 there were bare spots in the vegetative cover. Please ensure that the proper vegetative cover (80% coverage) is achieved on the site – some bare spots were seen on site.
- b. As shown in the photo 332 there was construction debris and waste material not properly stored. This material should be stored in a covered dumpster and properly disposed of. As described above the SWPPP does not contain the measures for waste storage and pollution prevention as required by Parts III.B.1.b and III.b.1.j of the CGP.
- c. The Site Plan for the Upper Site (Attachment 5) specifies that there will be two bio-retention areas (No. 1 and 2) with filter bed areas of 920 and 2,465 sq. ft respectively. Neither of these bio-retention areas was detected during this inspection.

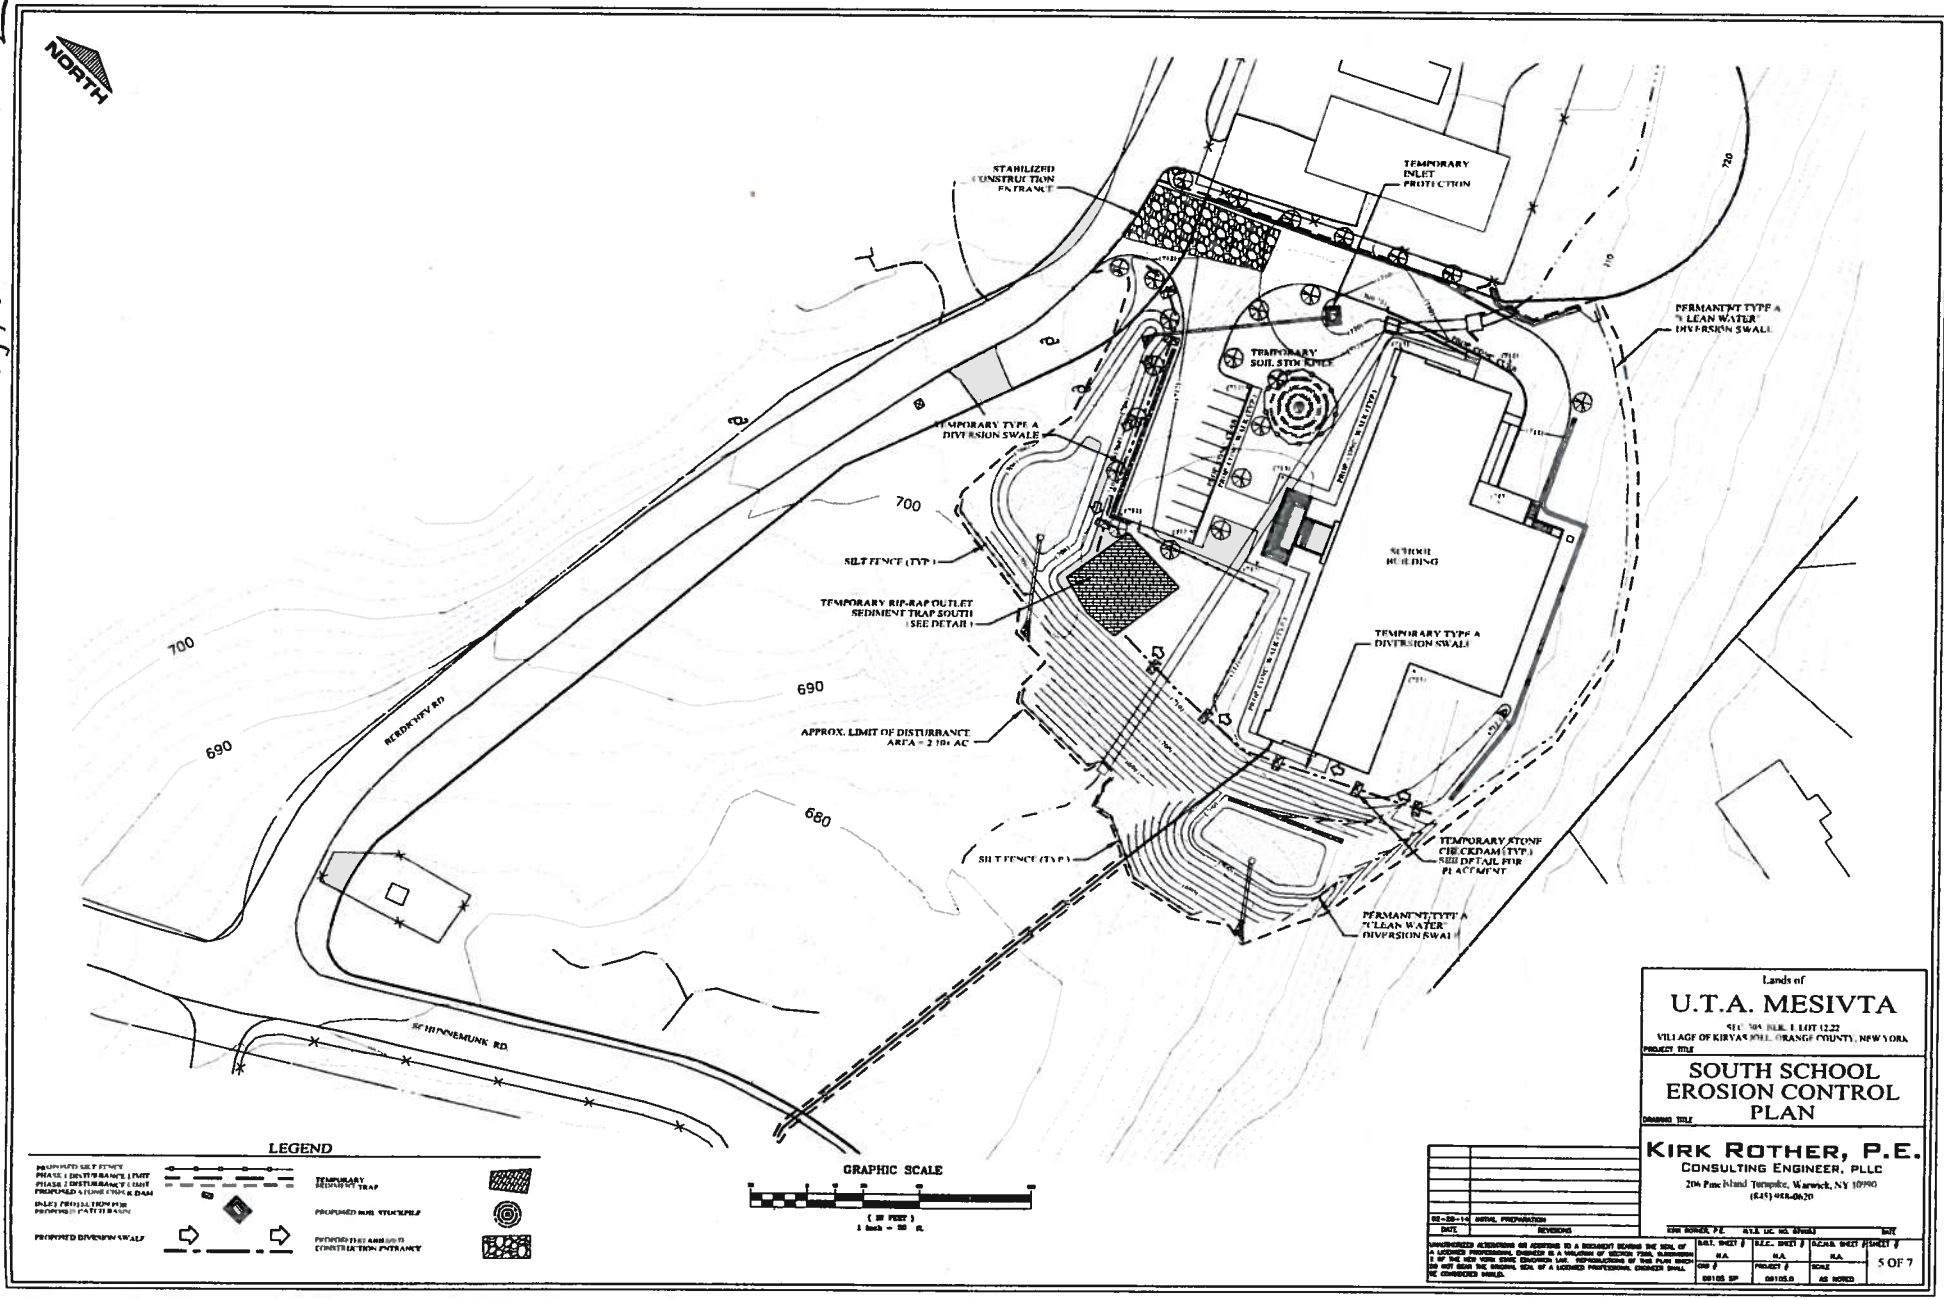
Attachment 2

- g. The Erosion and Sediment Control Plan (Attachment 2) for the lower site specifies that a sediment trap and series of check dams were to be constructed. The sediment trap and check dams were not detected during the inspection. What is the status of construction of the sediment trap and check dams at the Lower Site.

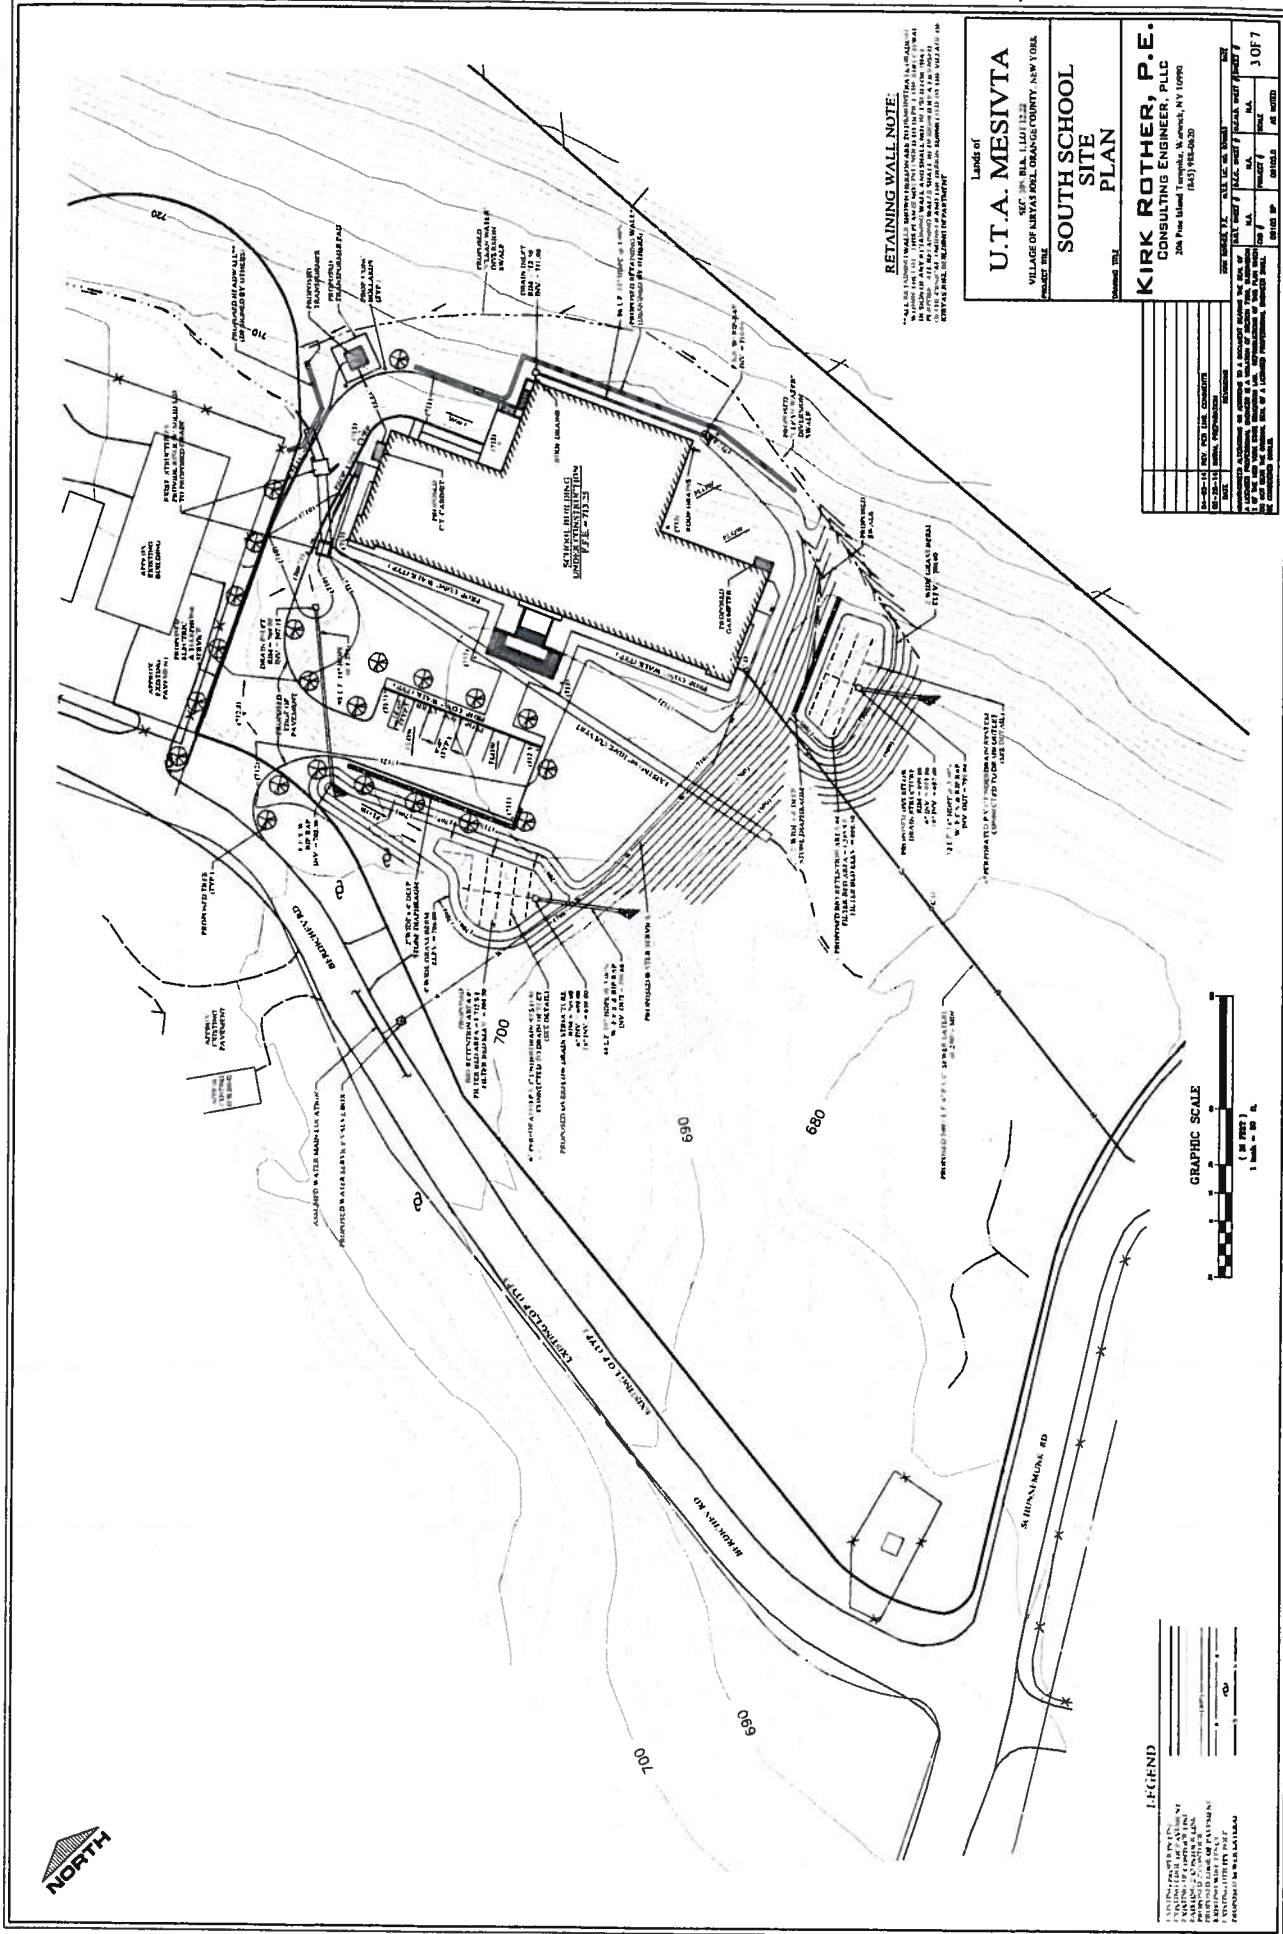
Attachment 4

- f. The Site Plan for the Lower Site (Attachment 4) specifies that there will be two bio-retention areas (No. 3 and 4) with filter bed areas of 1,715 and 1,585 sq. ft respectively. Neither of these bio-retention areas was detected during the inspection. Section VII, Construction Sequence, of the SWPPP sates that the bio-retention areas will be shaped and overflow structures installed.
